# **Mobile Pentium® II Processor Specification Update**

Release Date: May 1999

Order Number: 243887-010

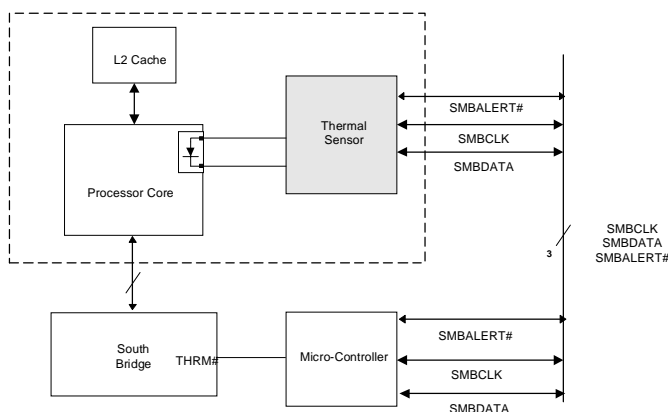
**Figure 1. An Example of Microcontroller Driven Thermal Management**

## B30. Thermal Sensor May Assert SMBALERT# Incorrectly

**PROBLEM:** The Mobile Pentium II processor and the Pentium II Processor Mobile Module have a thermal sensor that monitors the processor core's temperature. Please note that desktop systems could have a similar thermal device. The thermal sensor asserts SMBALERT# if the processor temperature exceeds the temperature limits set in the Alarm Threshold Registers (T<sub>HIGH</sub>, T<sub>LOW</sub>). It also sets the corresponding Status Register bits to identify the cause of the interrupt. Figure 1 gives one example of the how the SMBALERT# signal could be used in a system.

Under the conditions described below, the thermal sensor incorrectly generates the SMBALERT# interrupt. *All* of the following conditions must be met to trigger a false interrupt:
